Beach Nourishment Using Debris Flow Sediments : Lessons Learned

Sequence of Events

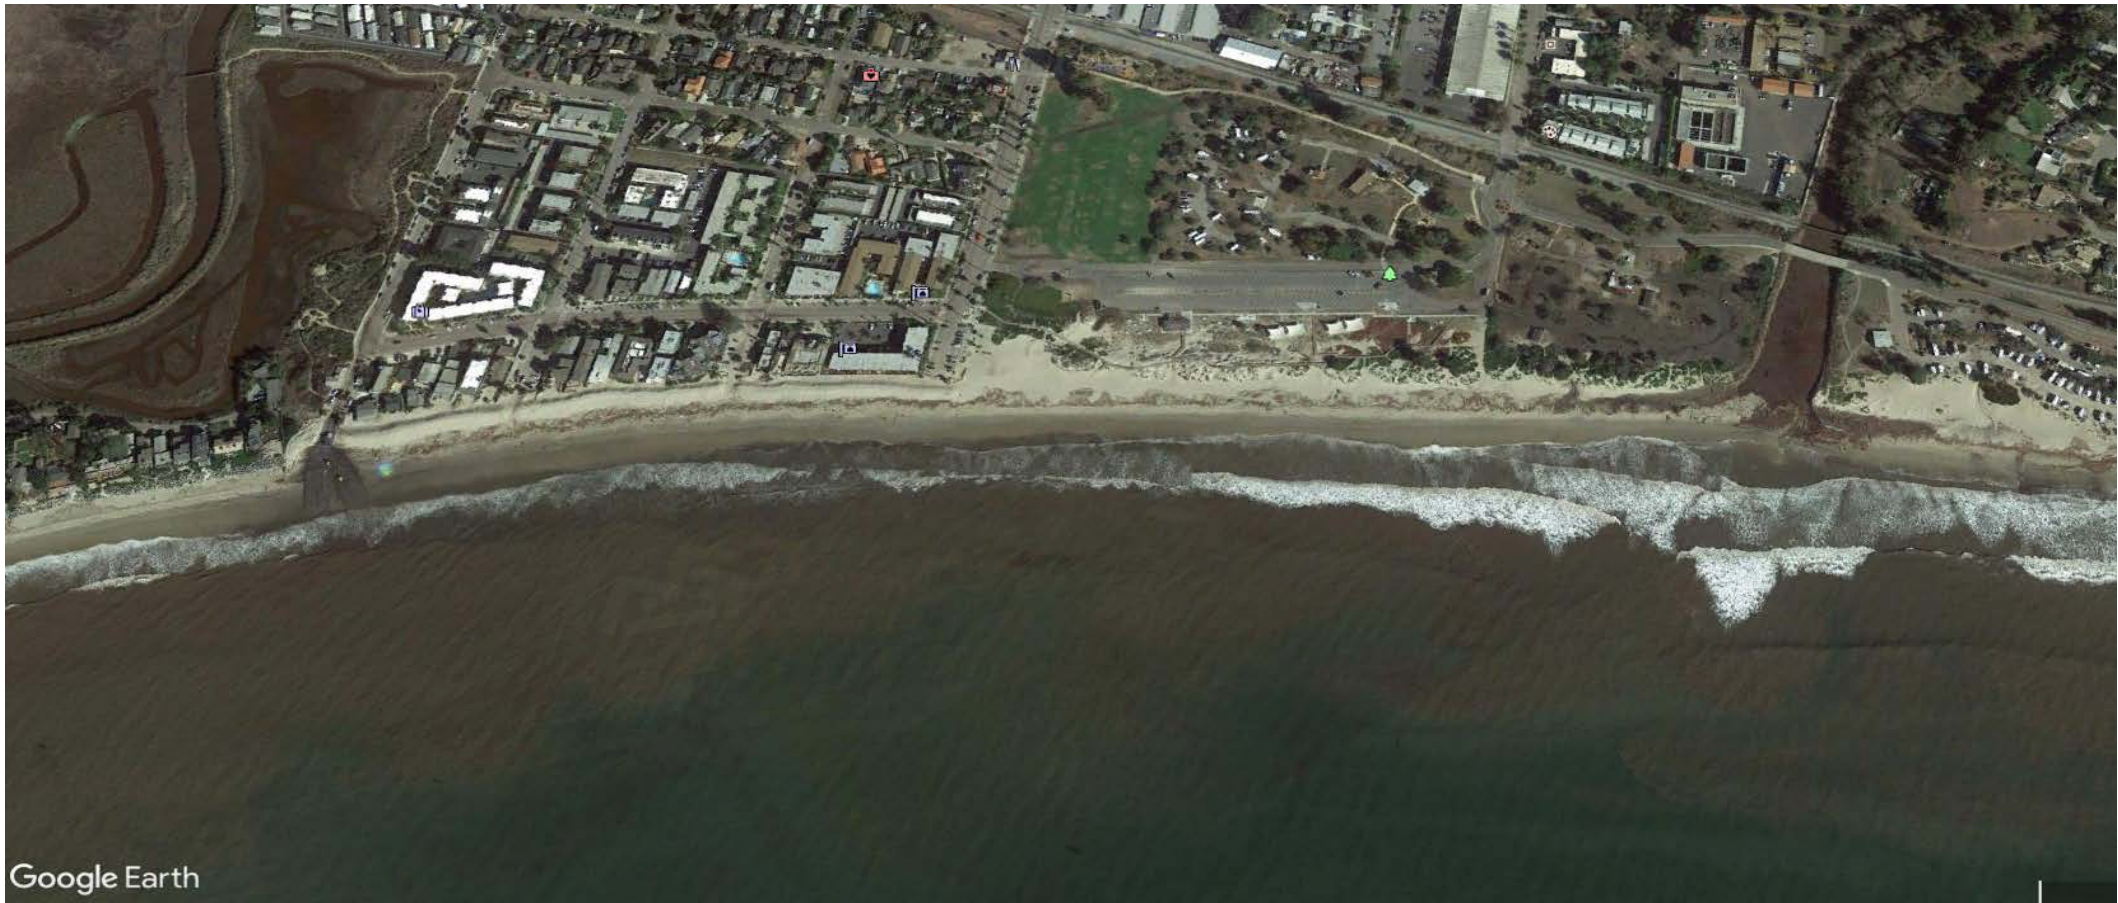
Carpinteria Beach – 12 January 2018

- 10 January 2018 – Nourishment begins & beach closed for swimming
- 9 February 2018 – Nourishment ends - 28,000 cy of sediment placed
- March 2018 – Beach re-opened for swimming
- April 2018 – Placement zone re-worked with heavy equipment
- Summer 2018 Onward – Sandy beach w/ no sign of debris sediments

- Carpinteria Beach recovered quickly because wave heights were larger and nourishment sediments were mostly sand-sized
- Goleta Beach recovered more slowly because wave heights were smaller and nourishment sediments had a substantial cobble fraction
- A cleaning and storage area is valuable when dealing with opportunistic sediment sources
- Having funding & permits in hand is critical for taking full advantage of opportunistic sediment sources

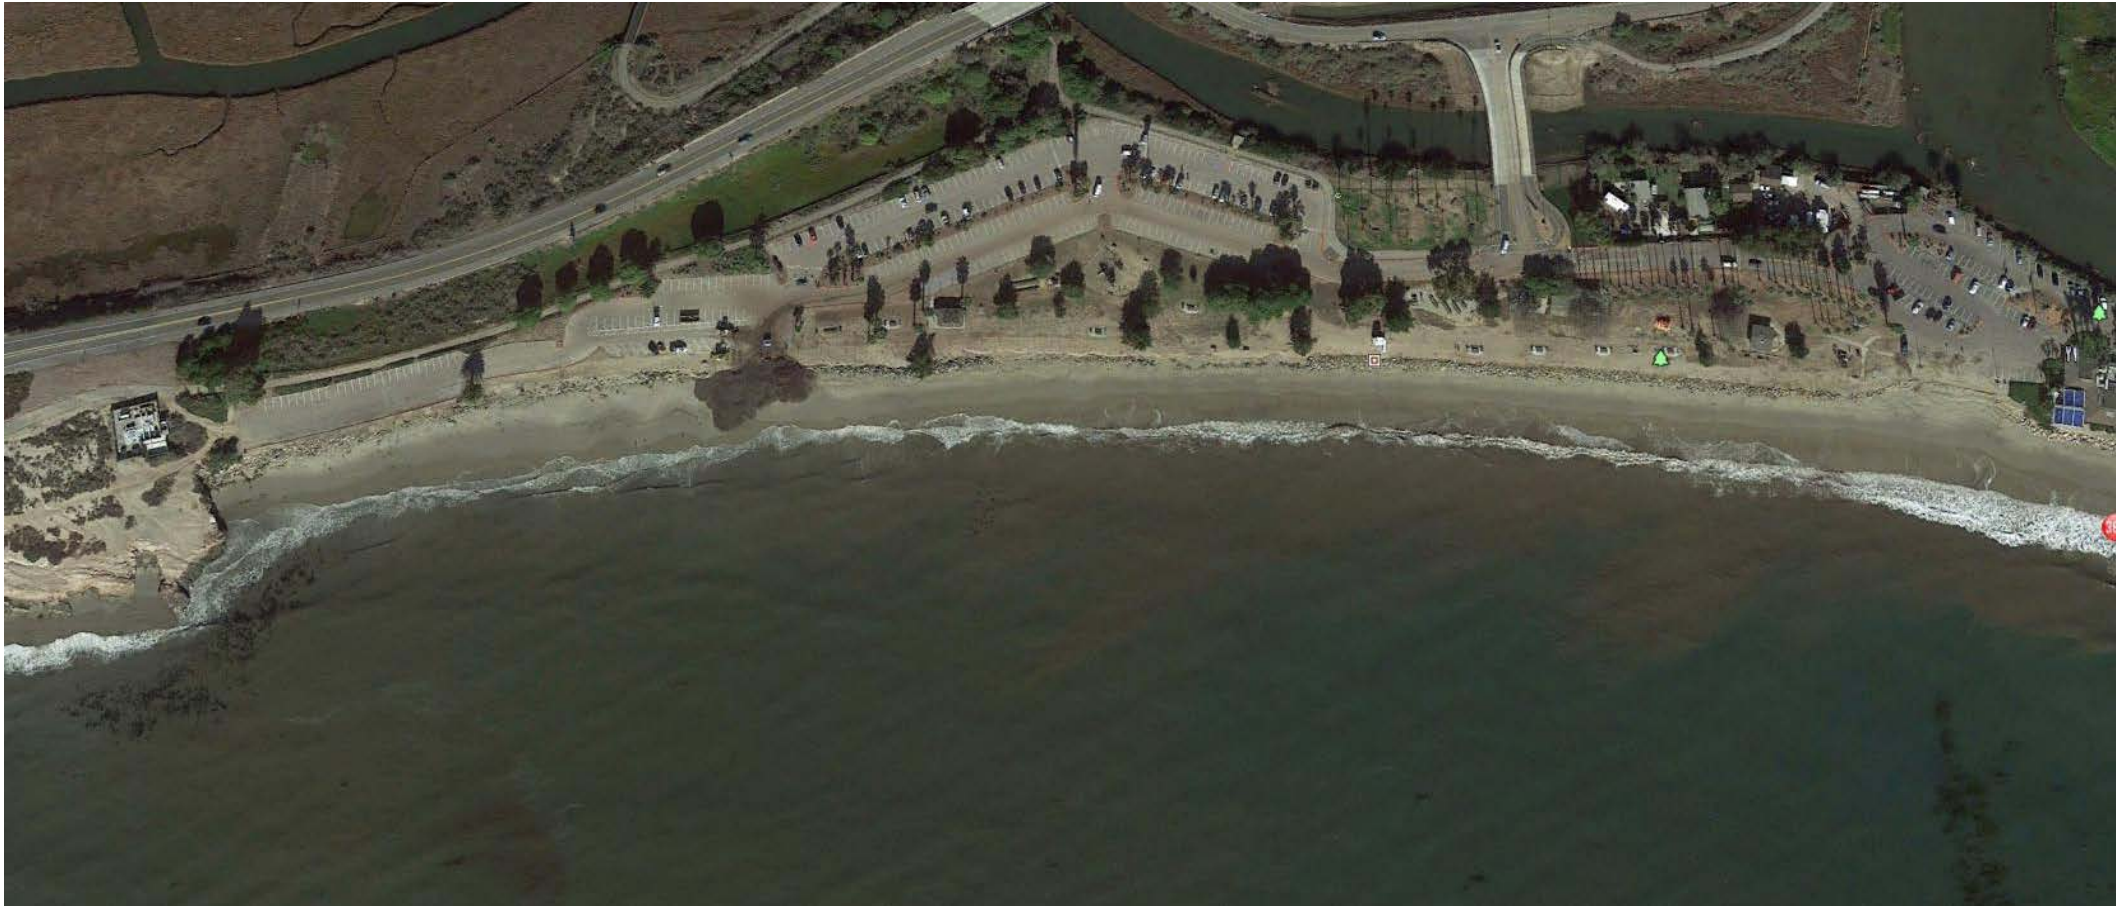
Goleta Beach – 12 January 2018

- 11 January 2018 – Nourishment begins & beach closed for swimming
- 20 February 2018 – Nourishment ends - 40,000 cy of sediment placed
- April 2018 – Nourishment zone re-worked with heavy equipment
- 6 July 2018 – Beach re-opened for swimming
- Summer 2018 – Sandy beach w/ extensive cobble berm
- January 2019 – Sandy beach w/ no visible cobbles
