USACE SAN FRANCISCO DISTRICT COASTAL STRUCTURES UPDATE

James Zoulas
Chief of Survey
Construction Branch, San Francisco District
12 November 2020

COASTAL STRUCTURES PROGRAM OVERVIEW

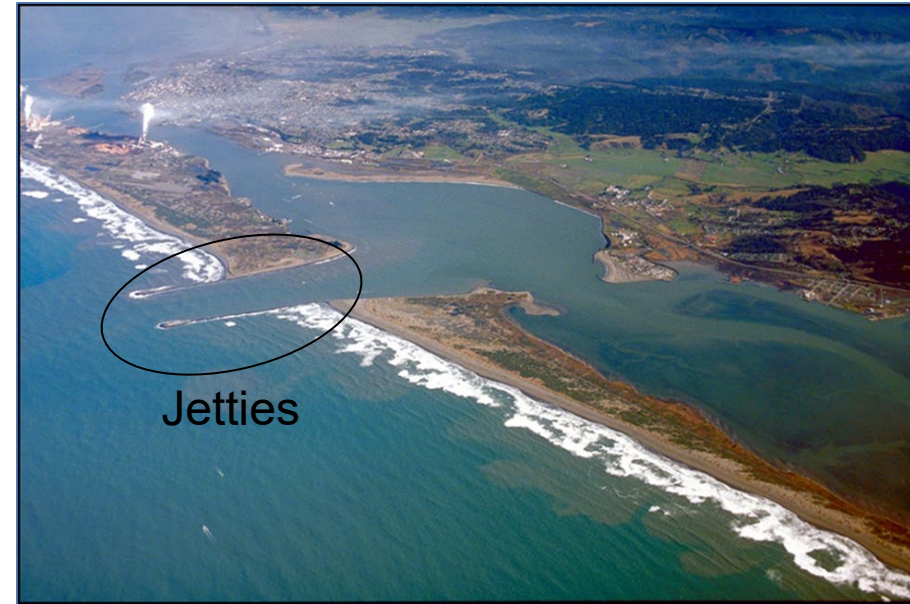
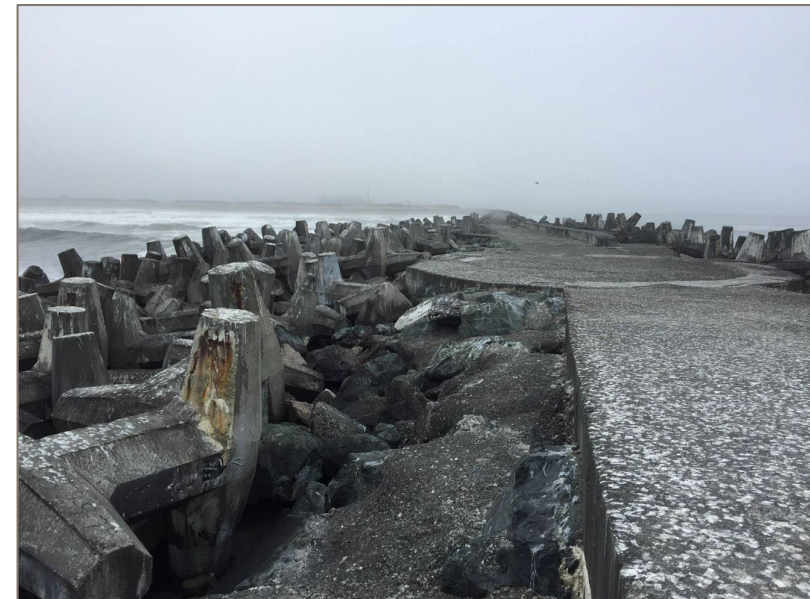
HUMBOLDT HARBOR

Parallel rubble mound jetties – 7,400 to 8,000 feet in length

Stabilize entrance to Humboldt Harbor between sandy spits

Originally constructed in late 19th Century

Major repairs throughout 20th Century

Dolosse added in early 1970s

Large sections capped with concrete for maintenance access

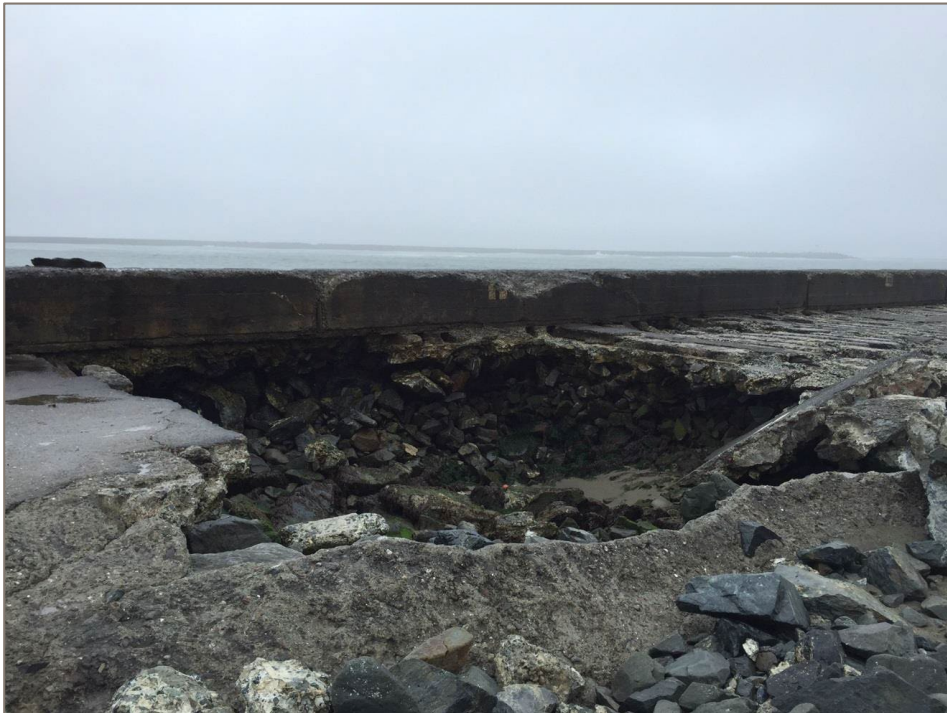
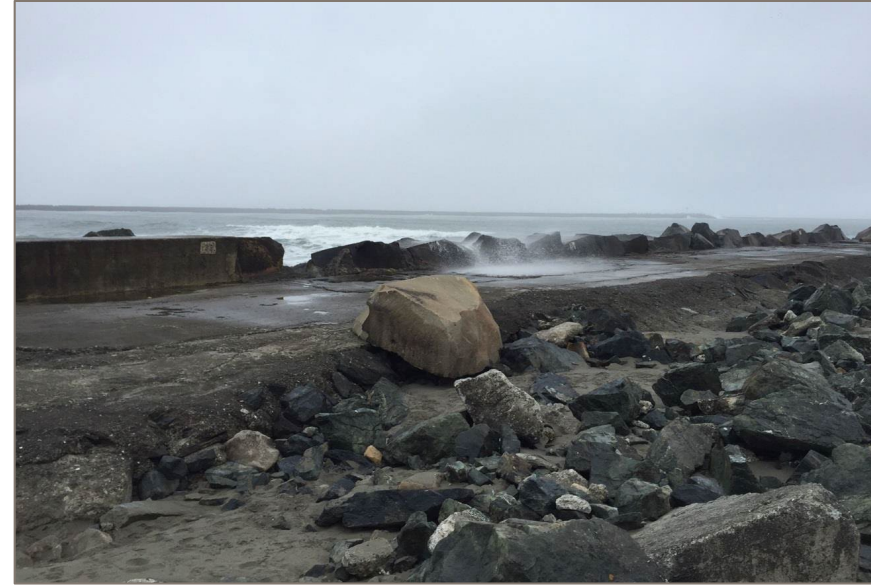
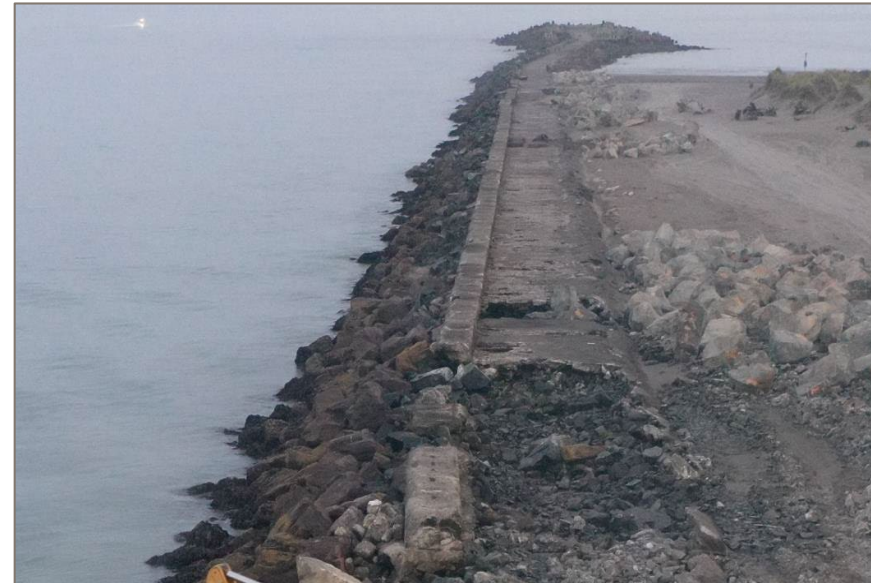
HUMBOLDT JETTIES DAMAGE

Significant damage to trunk section of North Jetty observed in 2010s

Numerous failures of concrete cap

Core stone “blown out”

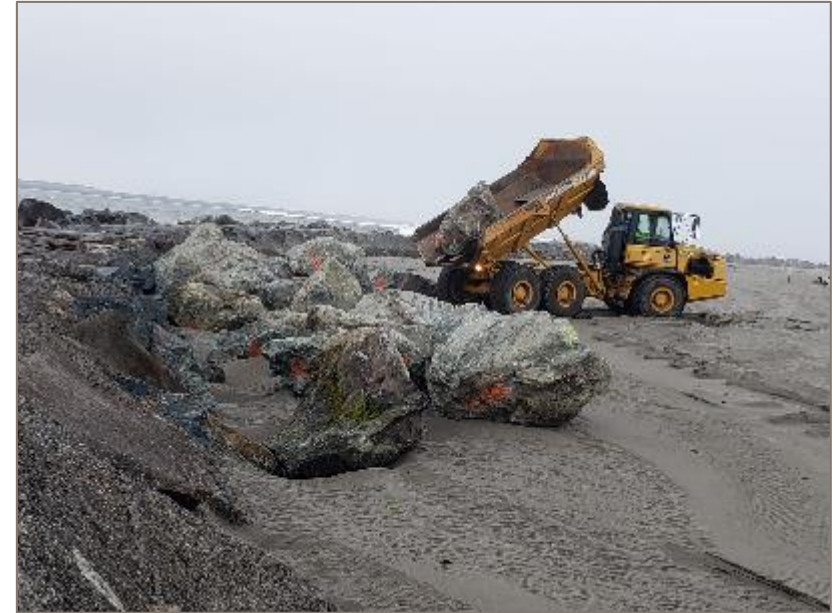
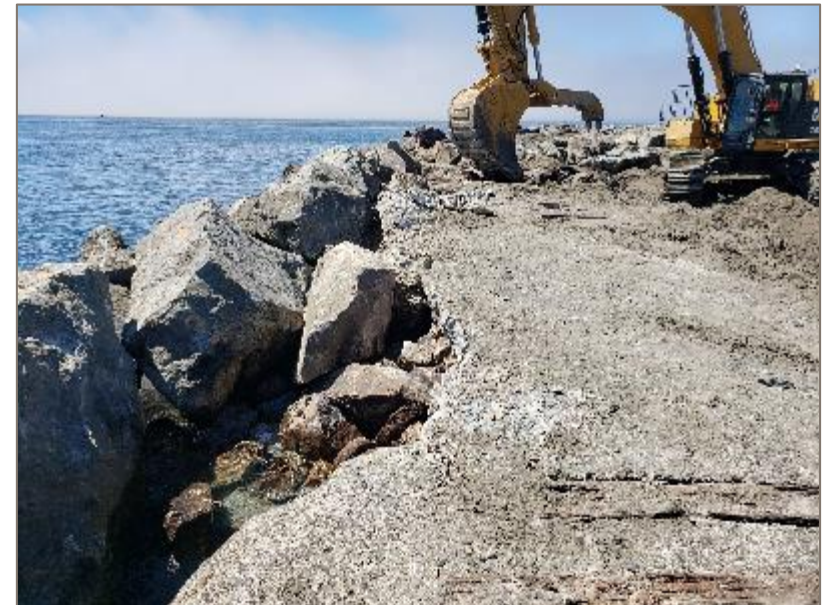
HUMBOLDT JETTIES REPAIR

Approximately 21,000 tons of armor stone for North Jetty

Approximately 31,000 tons of armor stones for South Jetty

Largest armor stones are approximately 20 tons

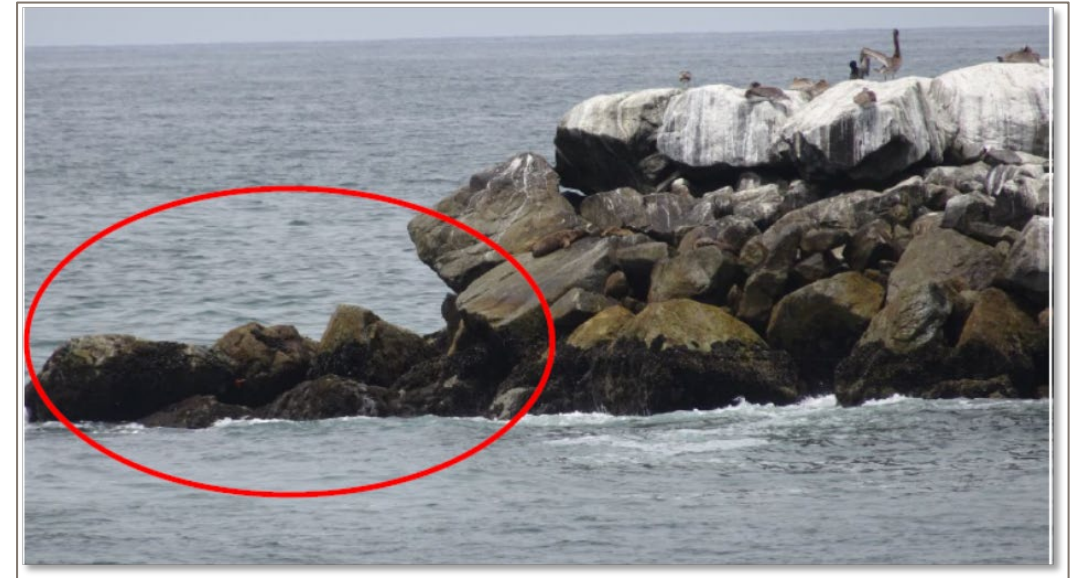
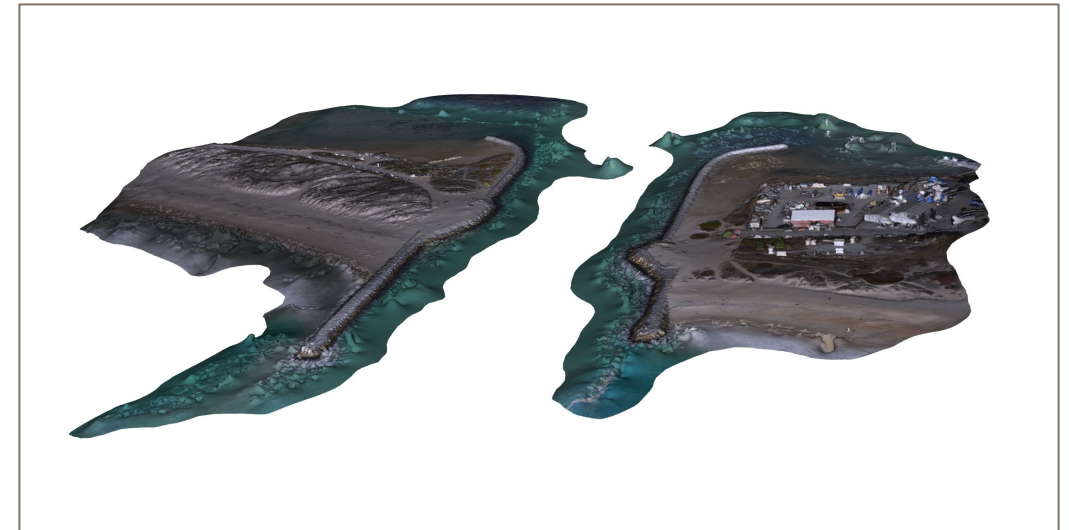
MOSS LANDING HARBOR

Parallel jetties of 1,520 and 1,550 feet in length

Last repaired in 2008

Significant degradation of head section of North Jetty

Topographic survey with small unmanned aerial system (sUAS) complete

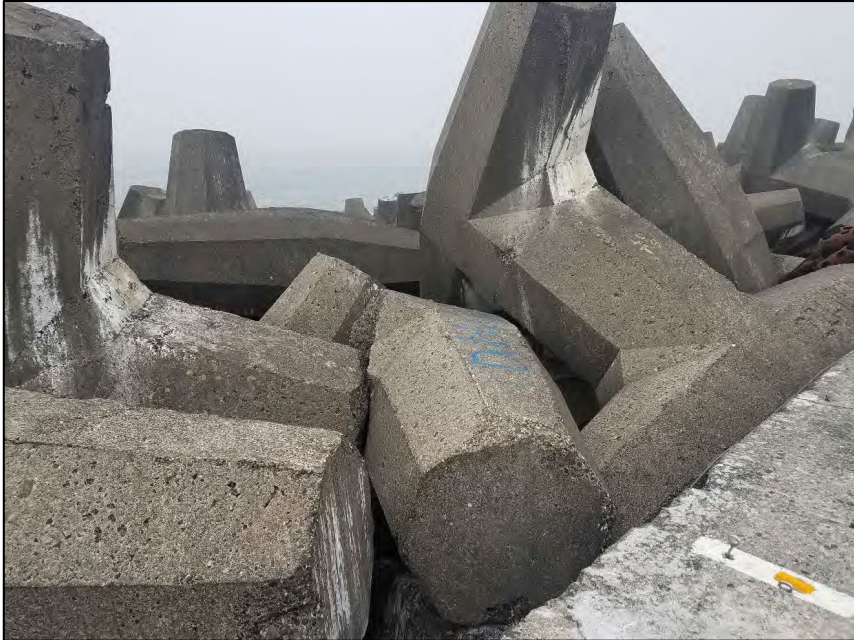
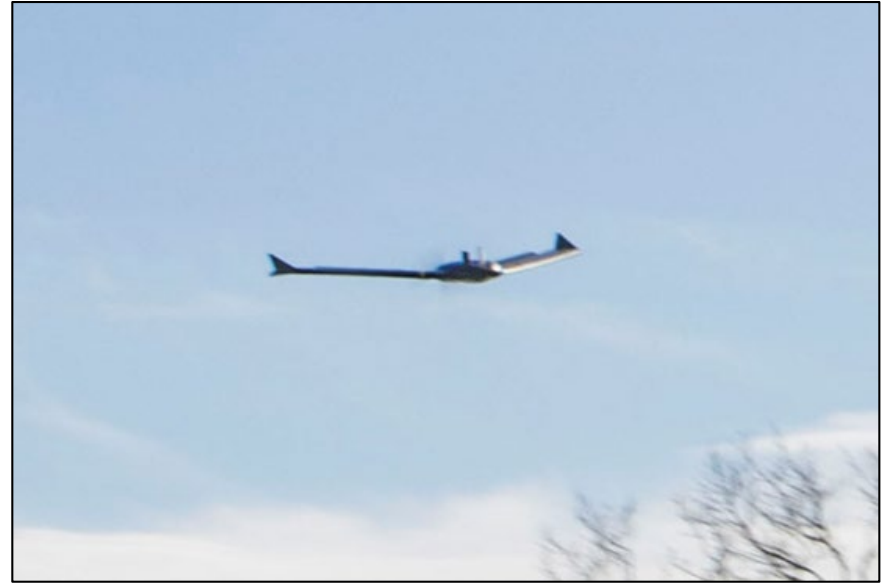
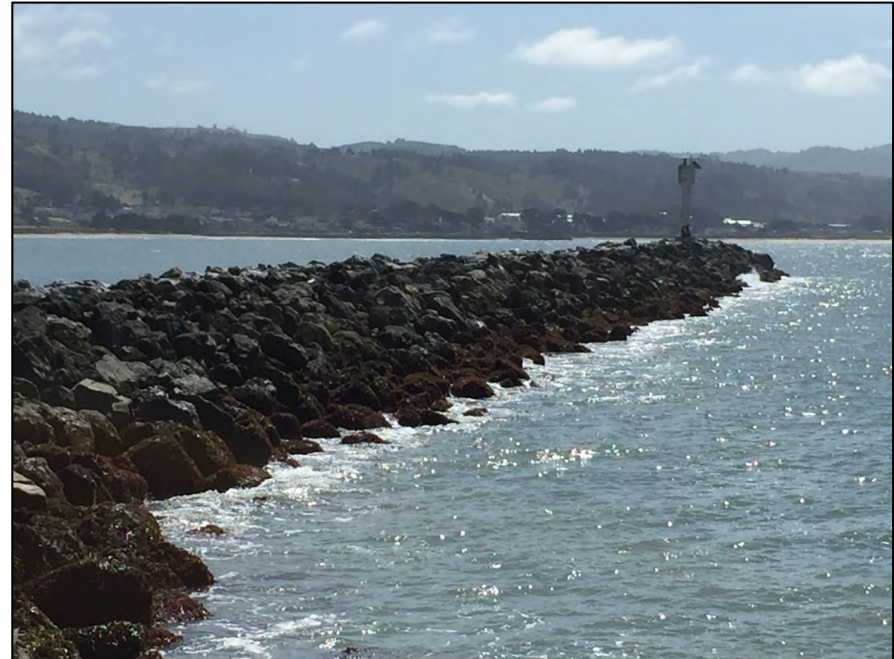
FY21 LOOK AHEAD

Pilot program to utilize sUAS to augment inspections
